Underfloor Air Mechanical Systems

Project Profile, Findings and Lessons Learned

Type:	Owner occupied office building
Location:	Kansas City, KS
Size:	6 stories 300,000 gross sq ft
Occupied:	Over 1 year

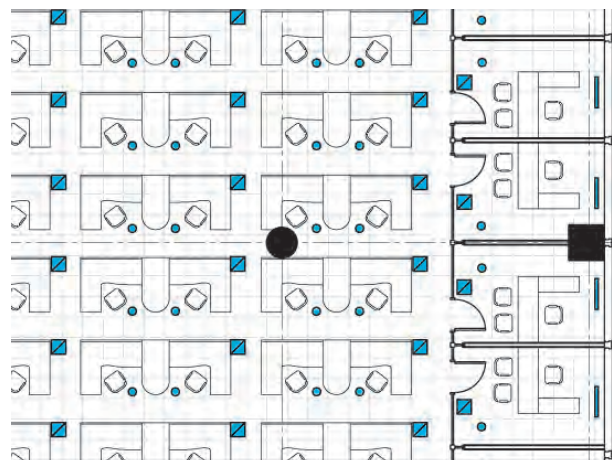
Figure 3: Diffuser (●) and return (■) locations for interior cubicles and private offices found along the perimeter of the building.

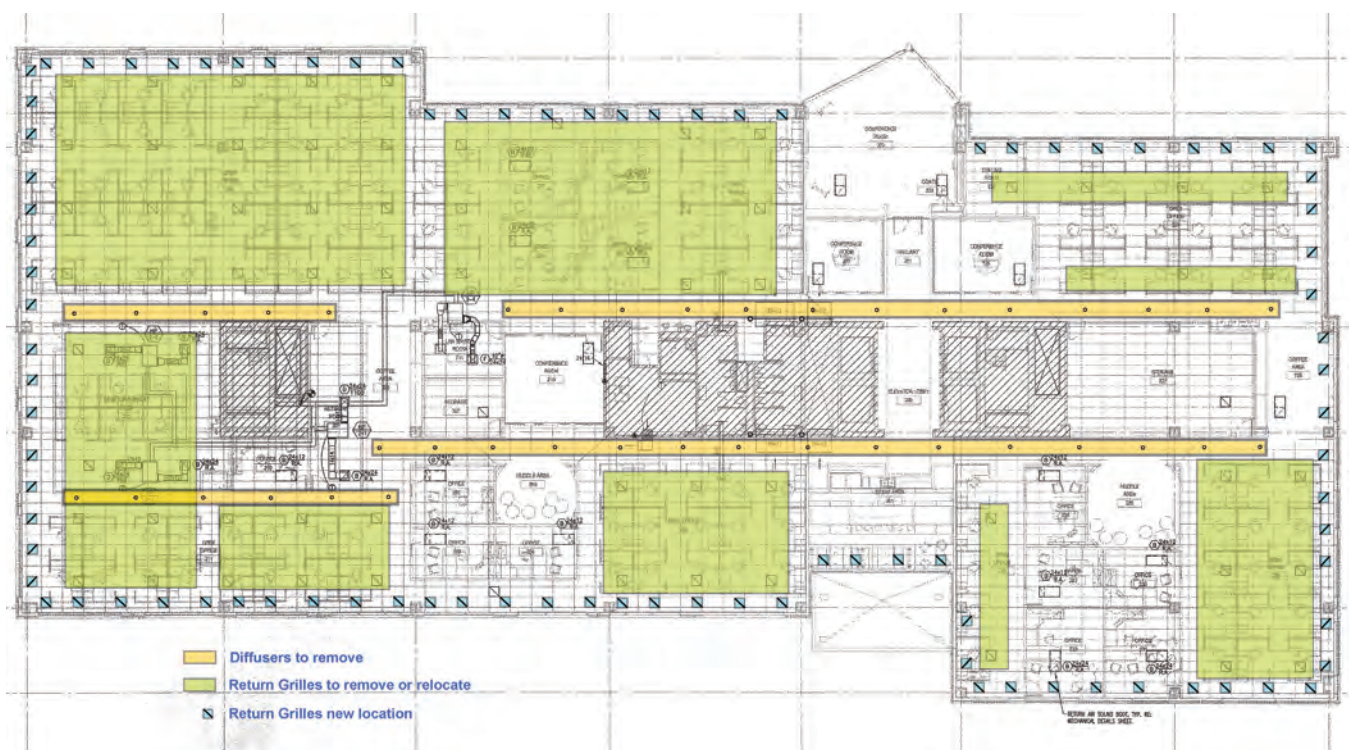
The average return air temperature was a few degrees below the average space air temperature.

It was determined that too many supply diffusers had been used in the interior zones causing supply air to be short circuited through return grilles. More air was being provided to the interior than the exterior zones. It was also determined that too many return air grilles in the interior zone. The interior zones being closer to the return shaft was actually pulling more return than needed from those areas.

Figure 4: Shows the interior zone supply diffusers that were removed and the return diffusers that were relocated along the perimeter.

Remove unnecessary interior supply diffusers and relocate return grilles to exterior zones. This resulted in warmer return air temperatures and cooler air delivered at perimeter. It also pulled more heat from the perimeter allowing supply air to replace it.

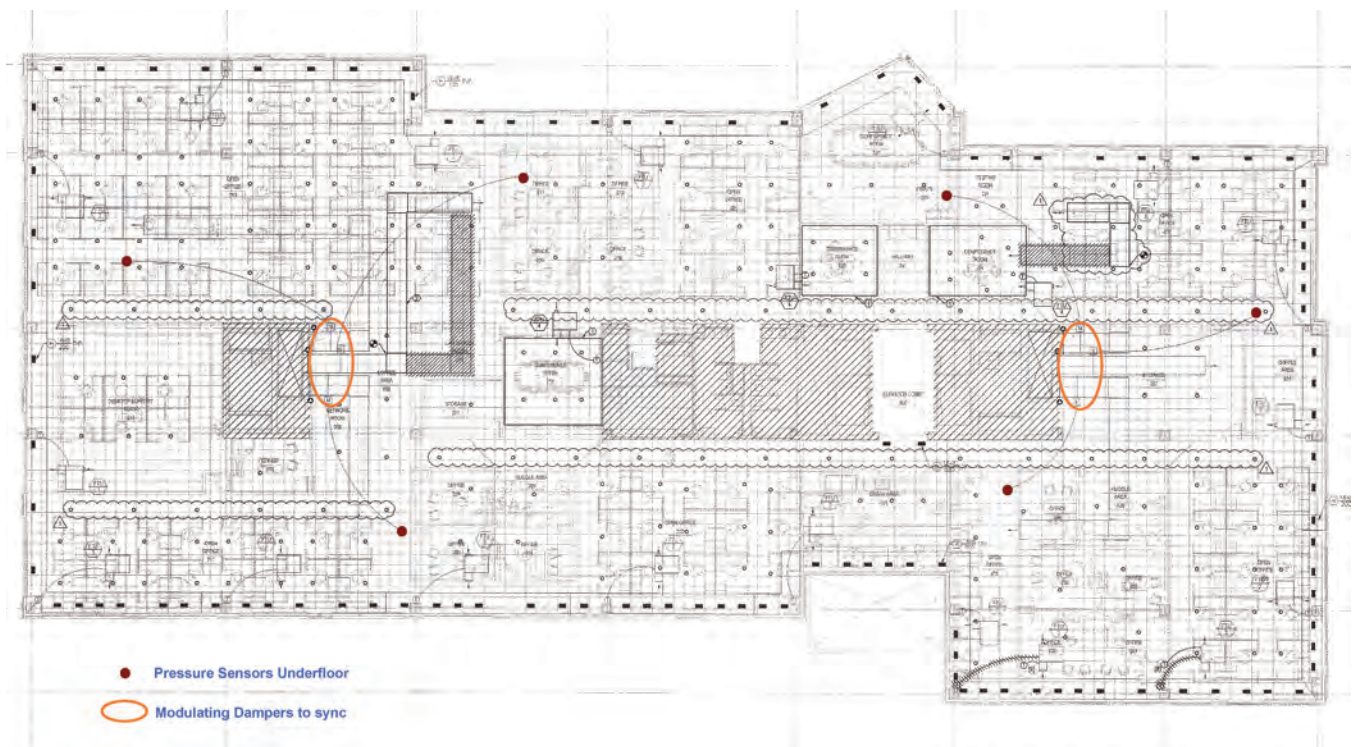
Mechanical equipment was supplying different air volumes between units for the same floorplate.

Each modulating damper was controlled by its own pressure sensor located under the floor. All modulating dampers were at different positions because their pressure sensor was satisfied at different times. This caused the air handlers serving each shaft to be loaded differently. Because the units were being controlled under a staggered start, the floor pressure would achieve steady state with dampers at different positions. Consequently, each air handler's fan speed would be different although shaft construction was nearly identical. This caused more air or less to be delivered through each shaft. In other words the plenum was being delivered with different capacities from each shaft.

Figure 5: The location of pressure sensors to average and modulating dampers to synchronize.

The pressures sensors were averaged and that signal was used to control all modulating control dampers in tandem. After control changes were accomplished the same amount of air was delivered out of each shaft.

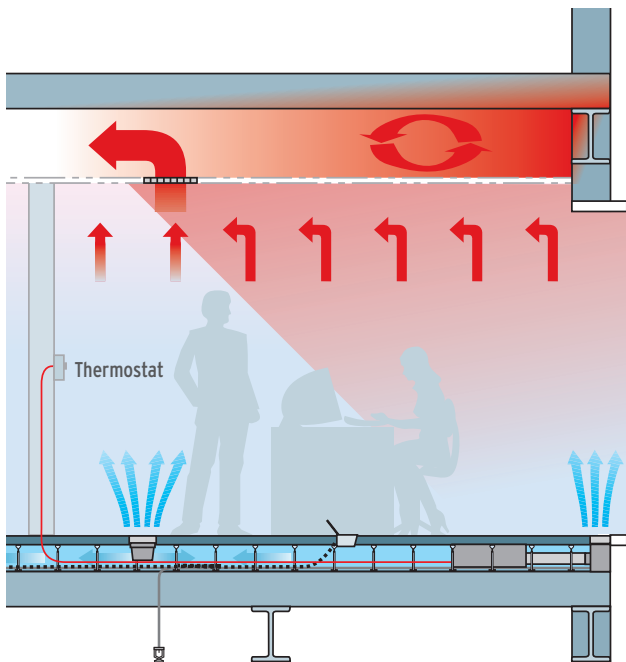
The size of the perimeter zone had been extended beyond the original design.

Figure 6: The location of the return grille and thermostat before corrections causing envelope load to be pulled further into the space.

Thermostats and return air grilles were moved back to the perimeter so they could monitor the zone the attached fan coils were serving. Additional manual diffusers and return air grilles were added to some offices in order to handle the loads appropriately. These modifications caused the exterior load to be contained to the exterior allowing the manual diffusers to handle the interior load.

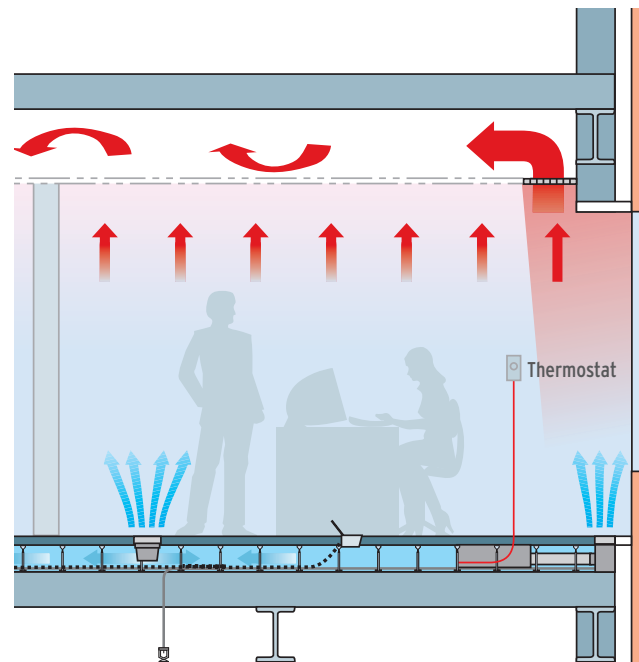
Figure 7: New location of larger return grille and thermostat that reduces the perimeter zone size to the original design.
