Underfloor Air Mechanical Systems: Project Profile, Findings and Lessons Learned

June 12, 2010

Type: Owner occupied office building
Location: Kansas City, KS
Size: 6 stories
300,000 gross sq ft
Occupied: Over 1 year

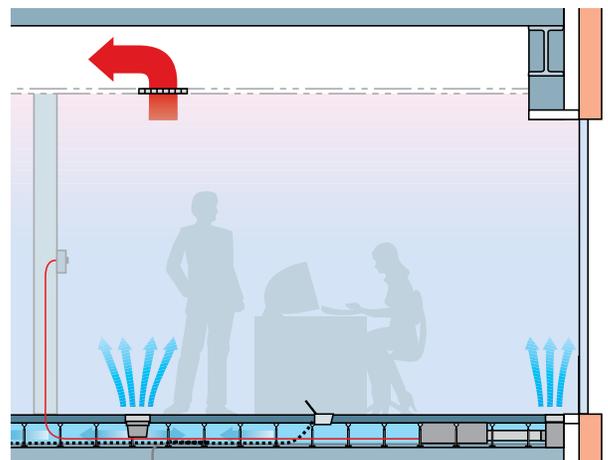
The perimeter system, designed to heat and cool the envelope of the building, consisted of fan coil units with electric heat and variable drive fan motors serving a perimeter plenum. Fan coils were located under the floor utilizing supply air from the plenum, providing supplemental heat to linear bar floor grilles located within 6" of perimeter walls. When in heating mode, warm air was provided through the linear grilles and in cooling mode cool plenum air.

Figure 2: Fan power boxes used for heating and cooling perimeter zone

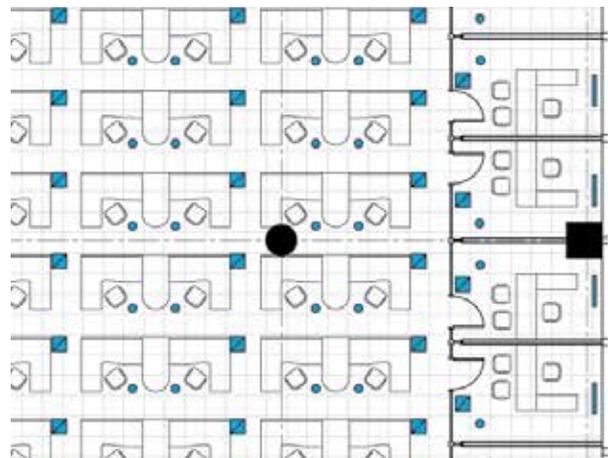
Figure 3: Diffuser (●) and return (■) locations for interior cubicles and private offices found along the perimeter of the building.

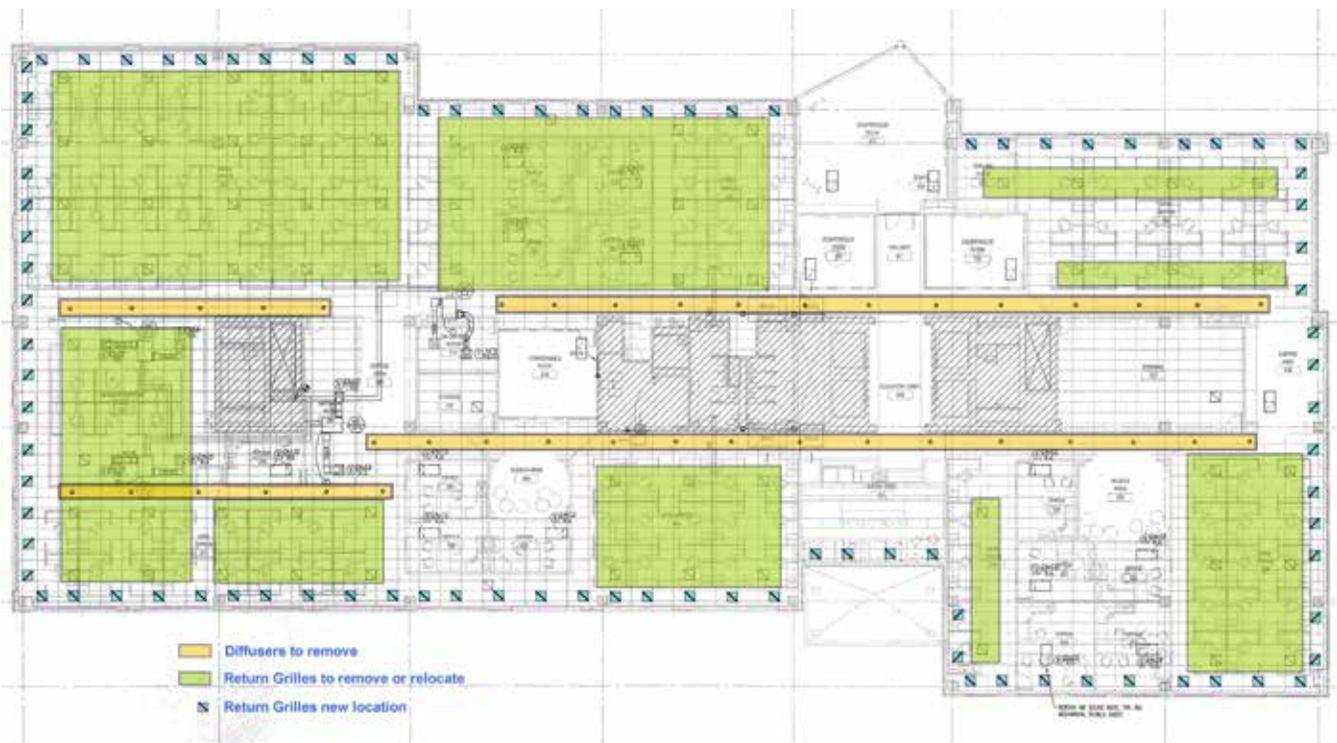
The average return air temperature was a few degrees below the average space air temperature.

It was determined that too many supply diffusers had been used in the interior zones causing supply air to be short circuited through return grilles. More air was being provided to the interior than the exterior zones. It was also determined that too many return air grilles in the interior zone. The interior zones being closer to the return shaft was actually pulling more return than needed from those areas.

Figure 4: Shows the interior zone supply diffusers that were removed and the return diffusers that were relocated along the perimeter.

Remove unnecessary interior supply diffusers and relocate return grilles to exterior zones. This resulted in warmer return air temperatures and cooler air delivered at perimeter. It also pulled more heat from the perimeter allowing supply air to replace it.

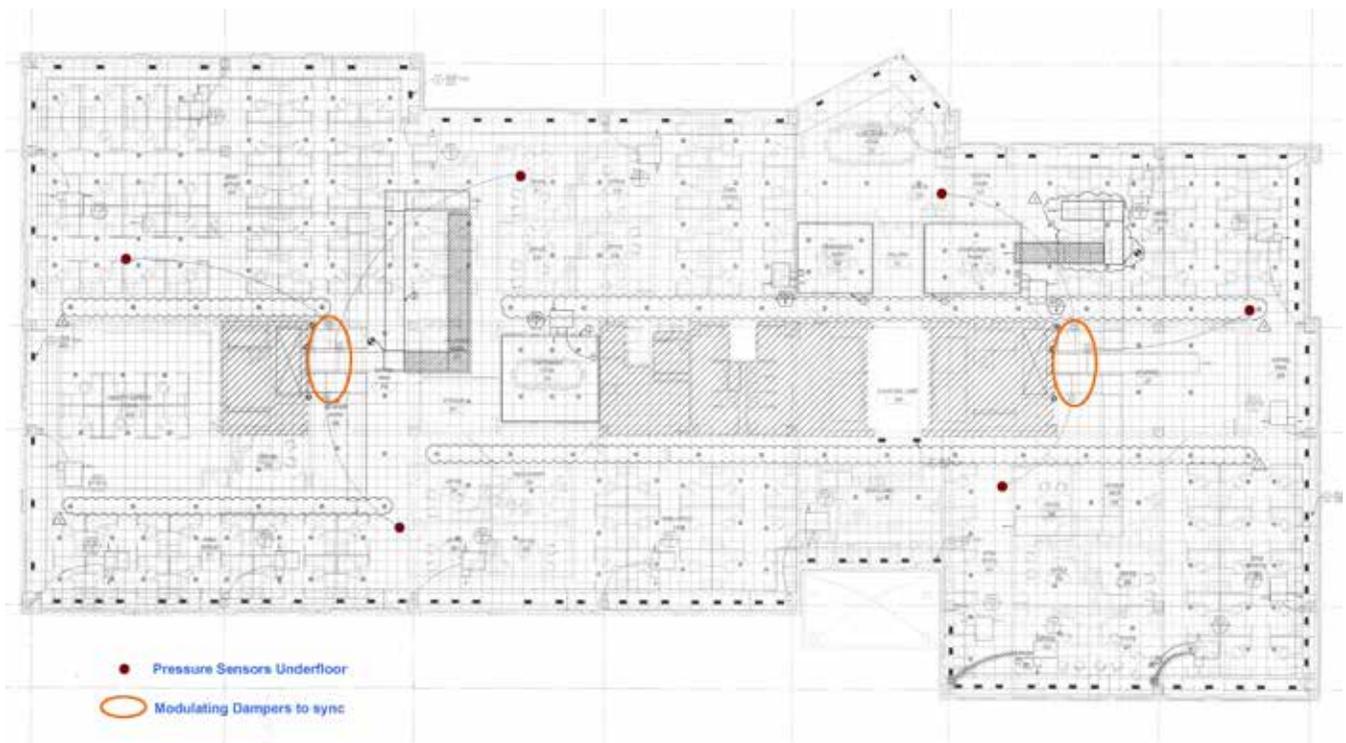
Mechanical equipment was supplying different air volumes between units for the same floorplate.

Each modulating damper was controlled by its own pressure sensor located under the floor. All modulating dampers were at different positions because their pressure sensor was satisfied at different times. This caused the air handlers serving each shaft to be loaded differently. Because the units were being controlled under a staggered start, the floor pressure would achieve steady state with dampers at different positions. Consequently, each air handler's fan speed would be different although shaft construction was nearly identical. This caused more air or less to be delivered through each shaft. In other words the plenum was being delivered with different capacities from each shaft.

Figure 5: The location of pressure sensors to average and modulating dampers to synchronize.

The pressures sensors were averaged and that signal was used to control all modulating control dampers in tandem. After control changes were accomplished the same amount of air was delivered out of each shaft.

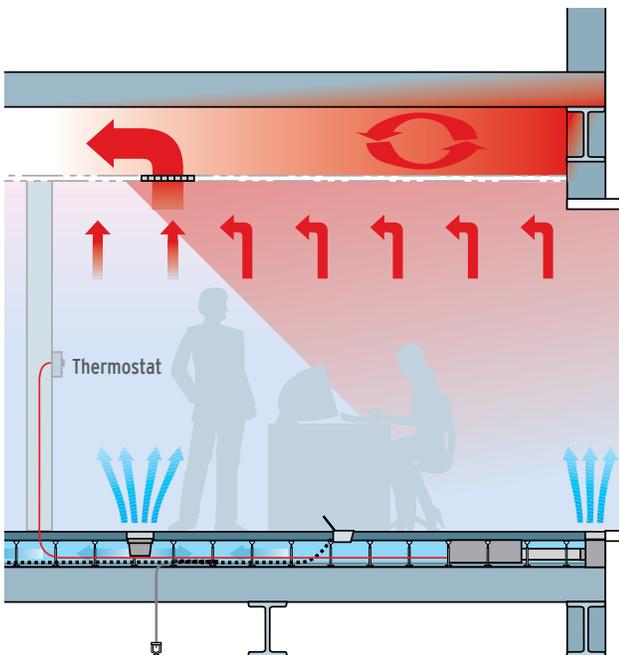
The size of the perimeter zone had been extended beyond the original design.

- 1) Perimeter office thermostats are sometimes removed or relocated during tenant improvement.
- 2) Placing return air grilles to far away from the perimeter wall causing the envelope load to be pulled further interior thus increasing the size of the exterior zone.
- 3) Extending interior office walls through the ceiling return air plenum causing excessive restrictions in return plenum.

Figure 6: The location of the return grille and thermostat before corrections causing envelope load to be pulled further into the space.

Thermostats and return air grilles were moved back to the perimeter so they could monitor the zone the attached fan coils were serving. Additional manual diffusers and return air grilles were added to some offices in order to handle the loads appropriately. These modifications caused the exterior load to be contained to the exterior allowing the manual diffusers to handle the interior load.

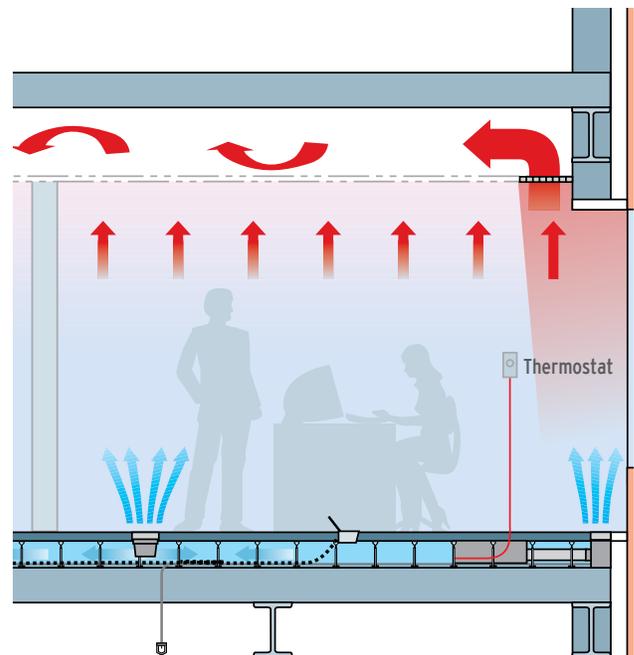
Figure 7: New location of larger return grille and thermostat that reduces the perimeter zone size to the original design.
